**SS SILVER DOVE; CARGO SHIFT AND SINKING
IN THE NORTH PACIFIC OCEAN ON 2 APRIL 1973
WITHOUT LOSS OF LIFE**

**U.S. COAST GUARD
MARINE BOARD OF INVESTIGATION REPORT
AND COMMANDANT'S ACTION**

**ACTION BY
NATIONAL TRANSPORTATION SAFETY BOARD**

REPORT NO. USCG/NTSB - MAR-76-1

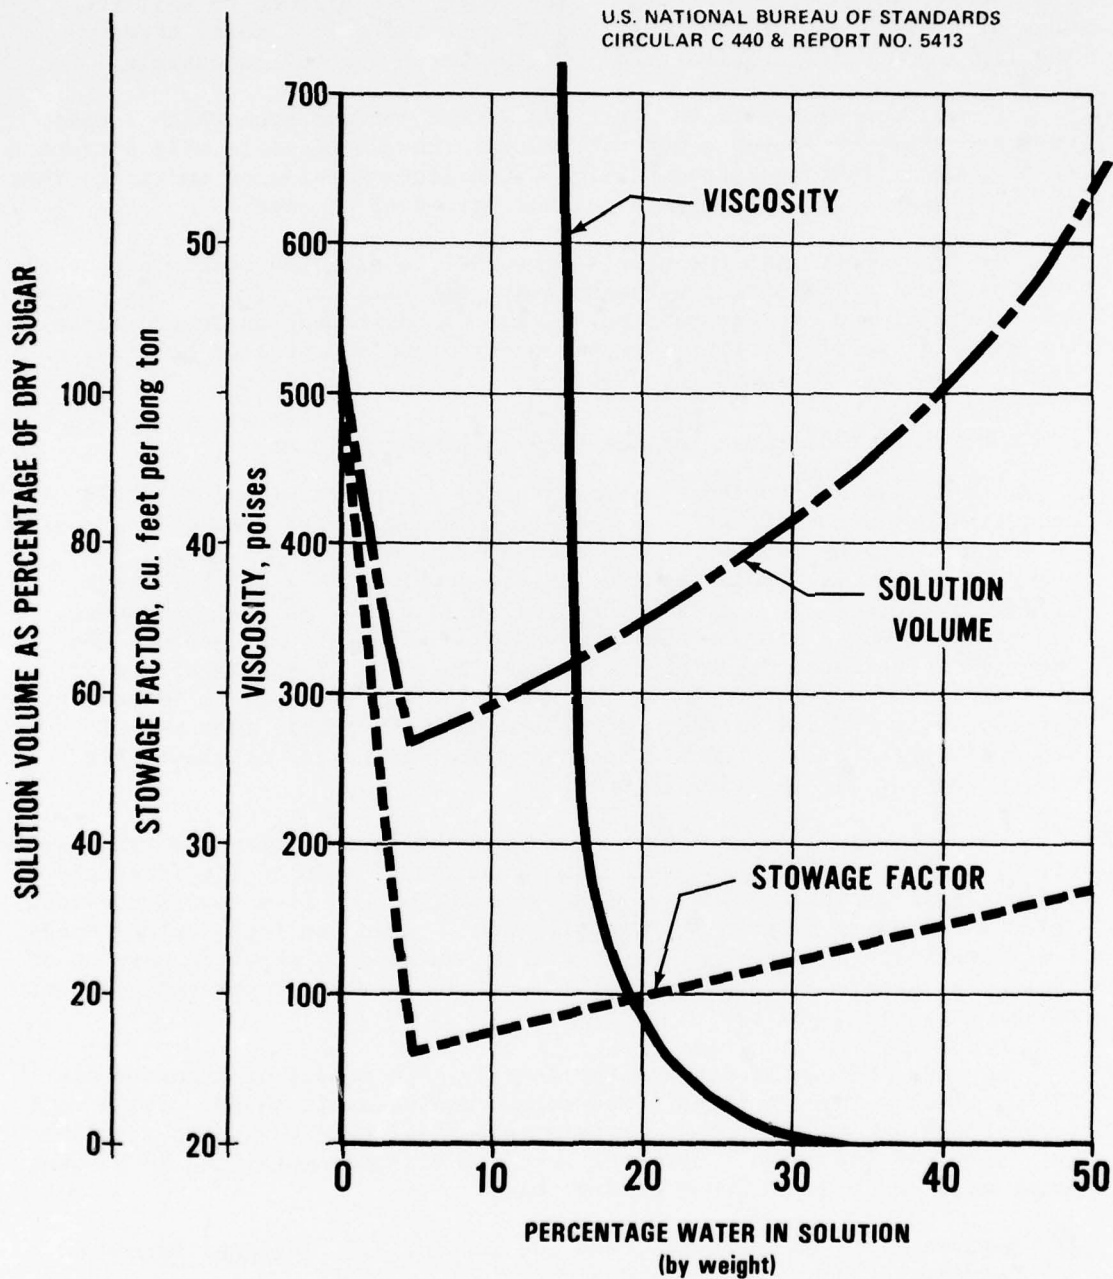
FIGURE 1. CHARACTERISTICS OF SUGAR SOLUTIONS

Raw sugar can also develop sufficient strength to support itself over regions where voids or cavities are created by the addition of water. Because of this, raw sugar in the SILVER DOVE's lower 'tween space and above may have remained above the hatch beams instead of feeding into the void that was created when sugar in the lower hold contracted as water was added. (See figure 2.)

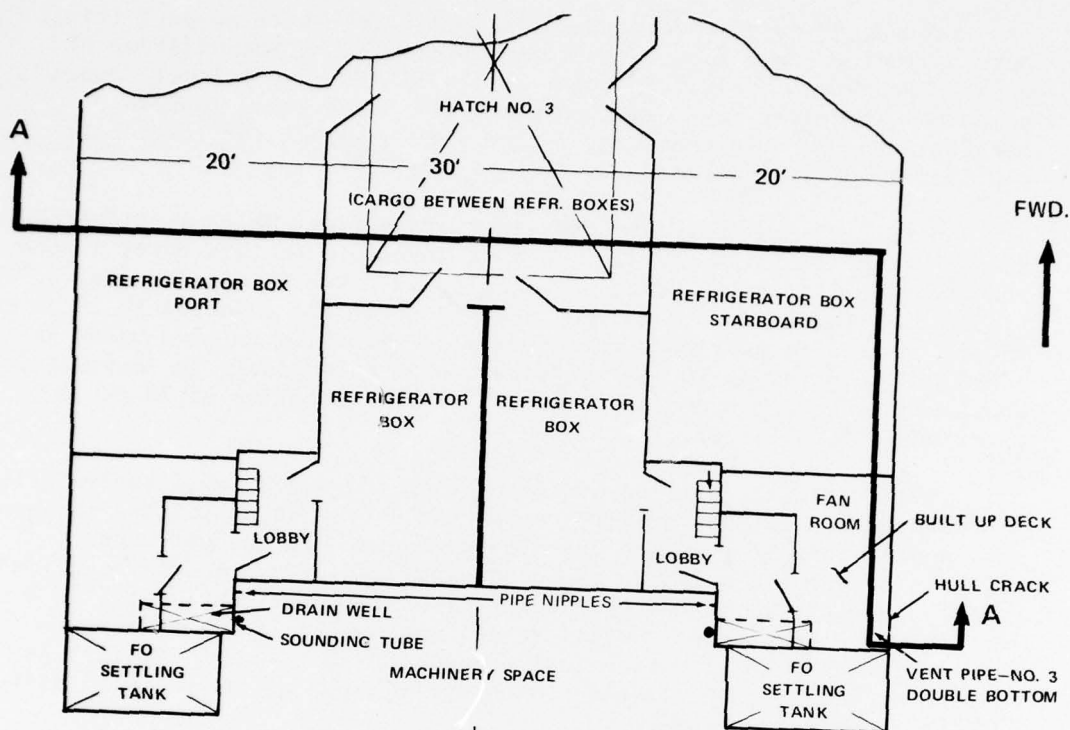
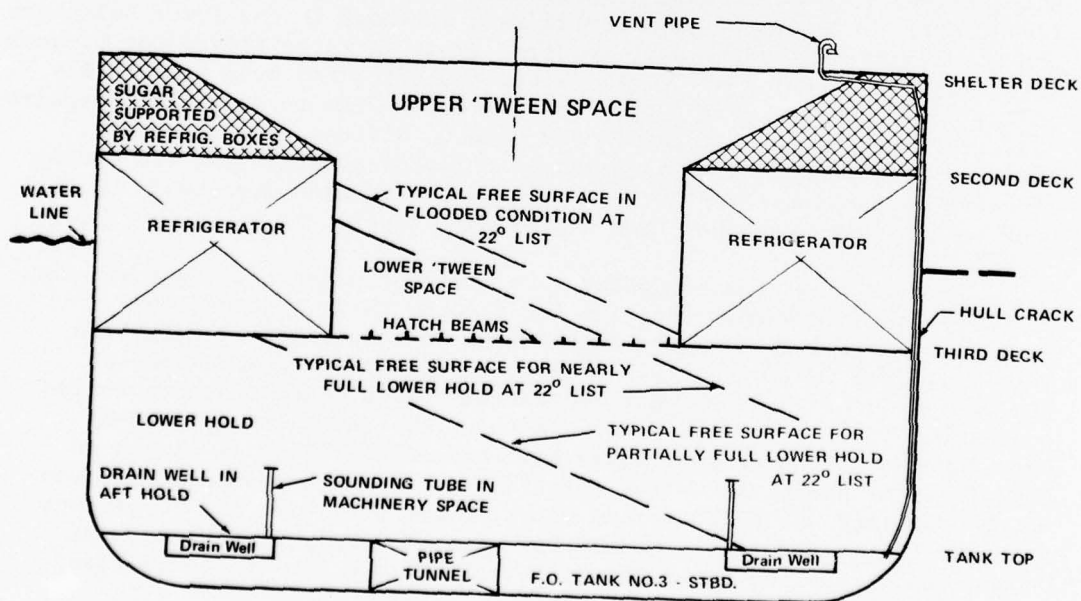
FIGURE 2. CARGO HOLD NO. 3

The results of this infiltration process were observed on the SILVER DOVE. When the cap was removed from the starboard pipe nipple before the ship arrived in Guam, a stream of granular sugar, followed by brown water, flowed out. This nipple was located in a bulkhead in the lower hold near the wet sugar. After the ship departed Guam, no water flowed out because water was not entering as quickly since the crack had been temporarily sealed and because the list to port induced in Guam to facilitate repairs had allowed the water already in the hold to diffuse into the sugar. However, since the water was entering on the starboard side, the amount of water in the sugar farther from the starboard side decreased, as confirmed by samples taken from a port pipe nipple.

The existence of a homogeneous solution of water and sugar was not a likely, or necessary, condition for a cargo shift. It was only necessary for the sugar-water solution on the starboard side to flow into a void on the port side. A large void could have developed on the port side if the dry sugar contracted into a concentrated solution containing just 10 percent water. A solution containing 20 percent water on the starboard side would have become sufficiently liquid to flow into the port void as the ship listed. (A heterogeneous solution which contained about 10 percent water on the port side and 20 percent water on the starboard side would have been a likely distribution of water considering the water was infiltrating from the starboard side;

this distribution would have required the infiltration of less than 315 LT of water. More than 315 LT of water could have leaked through the crack before the SILVER DOVE listed 22°.)

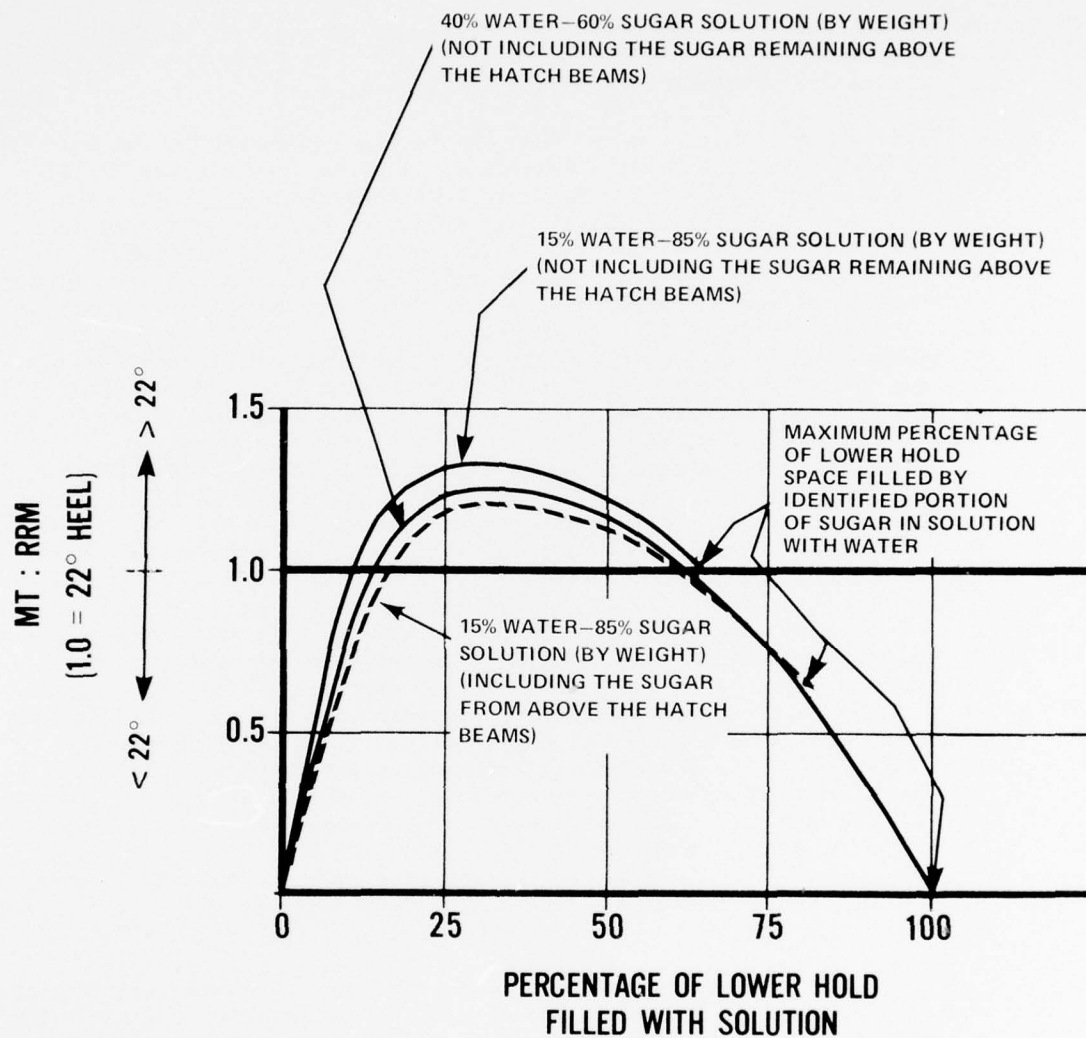
FIGURE 3. RANGE OF CARGO CONDITIONS NECESSARY TO CAUSE 22° LIST

For each sugar-water solution ratio, there is a maximum volume of solution that can be formed in the hold; it is determined from the dry sugar volume and the ratio of water and raw sugar in solution. (See figure 1.) The maximum volume of a solution containing 15 percent water and only the sugar in the lower hold would occupy about 65 percent of the lower hold space. A solution of 40 percent water and only the sugar from the lower hold would require slightly more space than that available in the lower hold. If the sugar above the hatch beams as well as that in the lower hold mixed with water to form a solution that was 15 percent water and 85 percent sugar, it would occupy about 81 percent of the lower hold space. (See figure 3.)

For the ratios of water and sugar considered, the 22° list of the SILVER DOVE would have developed when the sugar-water solution filled about 65 percent of the lower hold space. Greater quantities of solution would not have provided a sufficient void for a cargo shift to cause a 22° angle of heel. If the solution filled between 10 and 65 percent of the lower hold space, the angle of heel would have exceeded 22°. Quantities of solution in less than 10 percent of the lower hold space would not have weighed enough to cause the SILVER DOVE to heel 22°.

Nearly 500 LT of solution had to shift to cause the 22° angle of heel. The Coast Guard's calculation of the necessary weight shift, using a KG of 27.2 feet, differed from that of the Safety Board which determined the KG to be 25.9 feet before correcting for the effects of water in the cargo. The Coast Guard probably did not adjust its calculation to correct for the loss of free surface in the initially half-empty No. 2 double-bottom tanks and probably applied too large a correction for the free surface in No. 5 deep tanks at 22° heel angle.
